Chocolay Township

Signalized intersection locations on US-41/M-28 with crash summaries and collision diagrams for the years, 2000, 2001 and 2002.

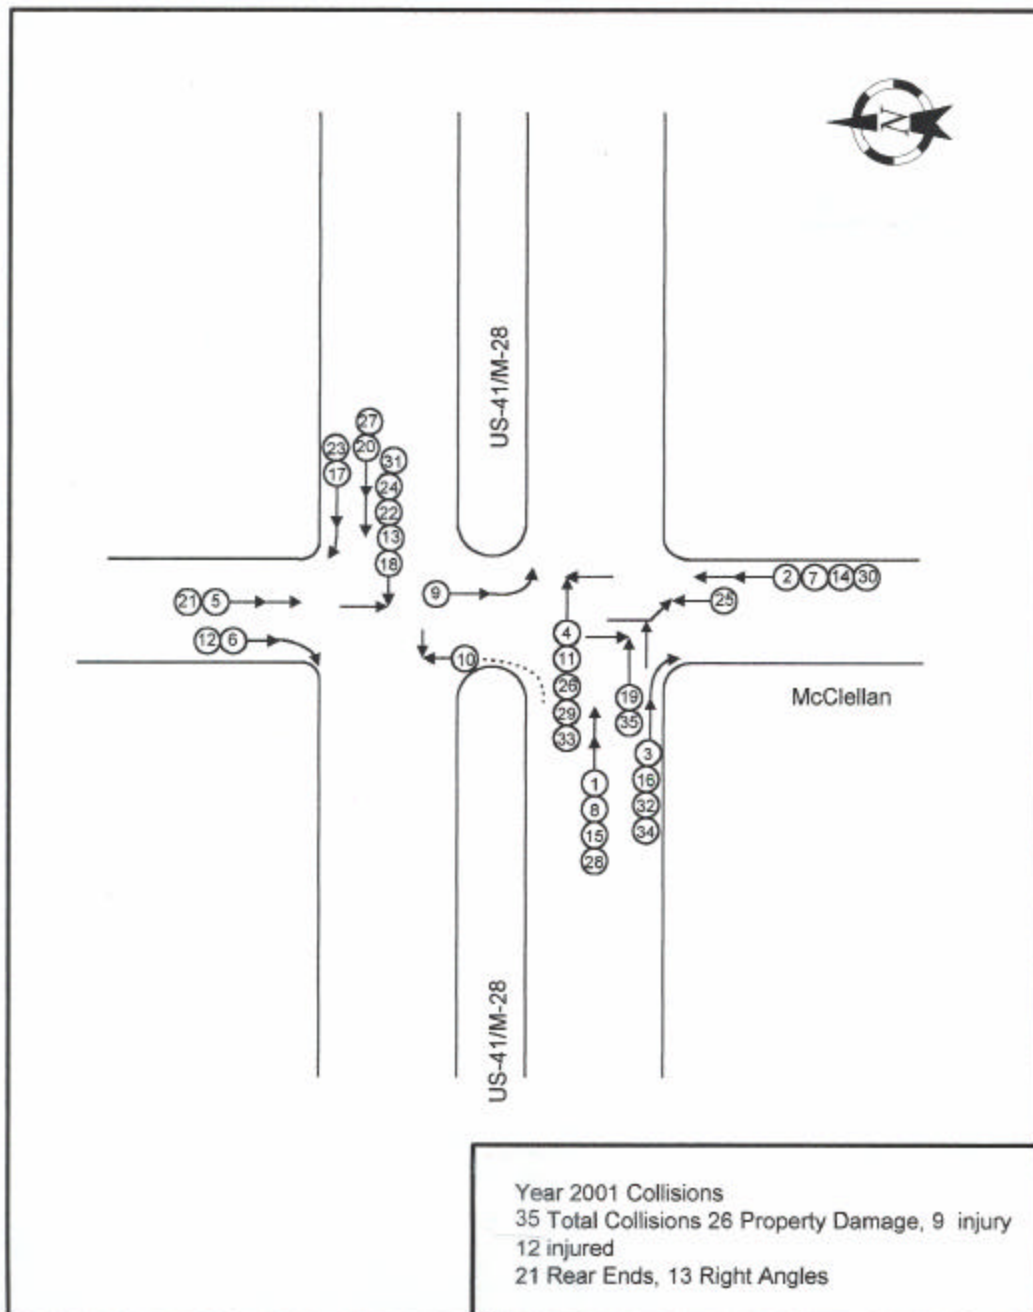
US-41/M-28 at McClellan St.
City of Marquette, Marquette County
Year 2001
Collisions Supplement Sheet

Diagram number	Date	Time	Severity	Type	# of vehicles	Direction of travel	Pavement Condition
1	1/05	1145	PD	RE	2	E	Icy
2	1/10	1640	PD	RE	2	N	Wet
3	1/18	1645	PD	RERT	2	E	Wet
4	1/19	0925	PD	Angle	2	W-N	Snowy
5	1/21	2030	PD	RE	2	S	Dry
6	2/15	1630	PD	RELT	2	S	Unk
7	2/17	1235	1-C	RE	2	N	Icy
8	2/21	1230	PD	RE	2	E	Icy
9	2/27	1330	PD	RELT	2	S	Wet
10	2/27	1335	1-B	Hd on LT	2	E-W	Wet
11	3/07	2300	1-C	Angle	2	N-E	Slushy
12	3/09	1450	PD	RERT	2	S	Wet
13	3/24	1202	PD	Angle	2	S-W	Wet
14	3/24	1210	1-C	RE	2	N	Wet
15	4/09	2115	PD	RERT	2	E	Dry
16	5/04	1140	PD	RERT	2	E	Dry
17	5/14	1050	PD	RERT	2	W	Dry
18	5/25	1240	1-B, 1-C	Angle	2	S-W	Dry
19	7/13	0900	1-C	Angle	2	S-E	Dry
20	7/16	1735	1-C	RE	2	W	Wet
21	7/27	1545	PD	RERT	2	S	Dry
22	7/30	2300	PD	Angle	2	N-W	Dry
23	8/06	1530	PD	RERT	2	W	Dry
24	8/13	2320	PD	Angle	2	S-W	Dry
25	8/20	1948	3-C	Angle	3	S-E-N	Dry
26	8/20	2200	PD	Angle	2	N-E	Dry
27	9/17	1300	PD	RE	2	W	Dry
28	9/19	1725	PD	RE	2	E	Wet

29	10/20	1905	PD	Angle	2	E-N	Dry
30	11/05	1850	PD	RE	2	N	Dry
31	11/10	1320	PD	Angle	2	S-W	Wet
32	11/23	0130	PD	RERT	2	E	Dry
33	12/15	0916	2-A	Angle	2	E-S	Dry
34	12/15	1830	PD	RERT	2	E	Dry
35	12/26	1600	PD	Angle	2	S-E	Snowy

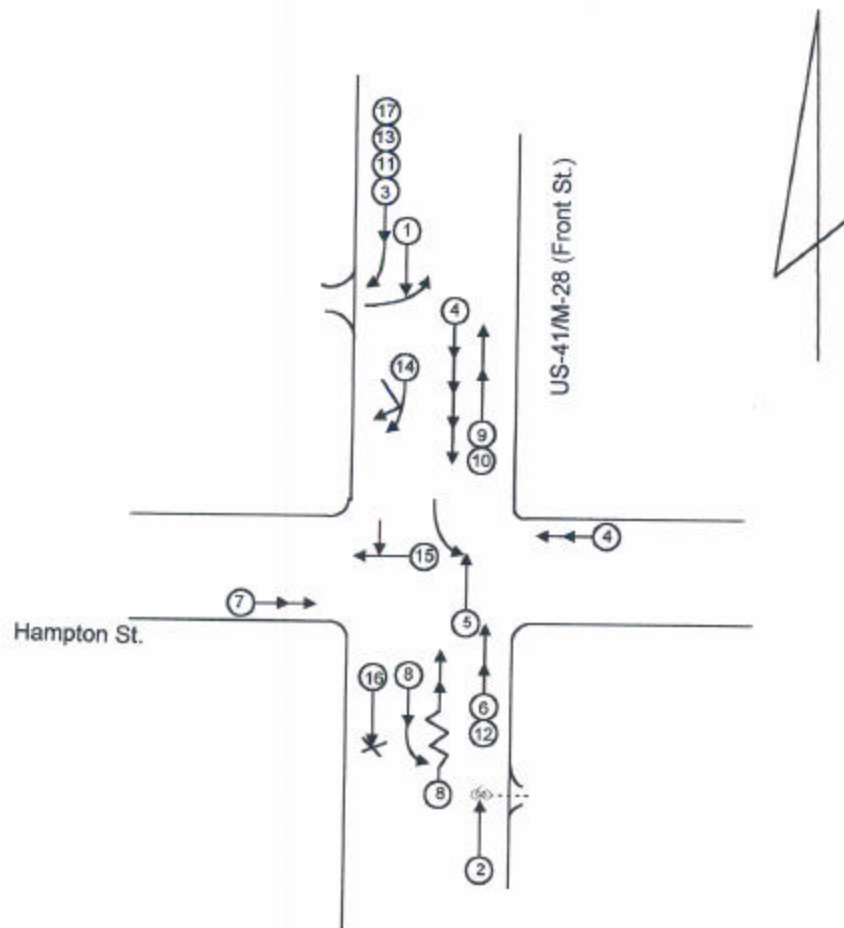
US-41/M-28(Front) at Hampton St.
City of Marquette, Marquette County
Years 2000, 2001 & 2002
Collisions Supplement Sheet

Diagram number	Date	Time	Severity	Type	# of vehicles	Direction of travel	Pavement Condition
1	3/11/00	1730	PD	Dr' Rt A	2	S-E	Dry
2	6/25/00	1210	PD	Misc	1	NBd	Dry
3	7/19/00	1640	PD	Dr' RE RT	2	SBd	Dry
4	8/23/00	1900	Unk	RE	4	SBd	Dry
5	11/21/00	0800	Unk	Hd on LT	2	N-S	Wet
6	12/05/00	0930	Unk	RE	2	NBd	Icy
7	12/08/00	1515	PD	RE	2	Ebd	Icy
8	12/18/00	1155	1-C	Dr' RE LT	2	SBd	Slushy
9	1/06/01	0955	1-C	RE	2	NBd	Slushy
10	2/01/01	0715	PD	RE	2	NBd	Wet
11	3/21/01	0750	PD	Dr' RE RT	2	SBd	Wet
12	6/01/01	1000	PD	RE	2	NBd	Wet
13	8/31/01	1348	1-C	Dr' RE RT	2	SBd	Dry
14	3/10/02	1900	PD	SS SM	2	SBd	Icy
15	4/18/02	1725	1-C	Angle	2	S-WBd	Dry
16	8/22/02	2100	PD	Misc	1	SBd	Dry
17	10/24/02	2045	PD	Dr' RE RT	2	SBd	Dry

17 Total Collisions - 11 Property Damage, 4 injury
11 Rear Ends - 3 on wet pavement

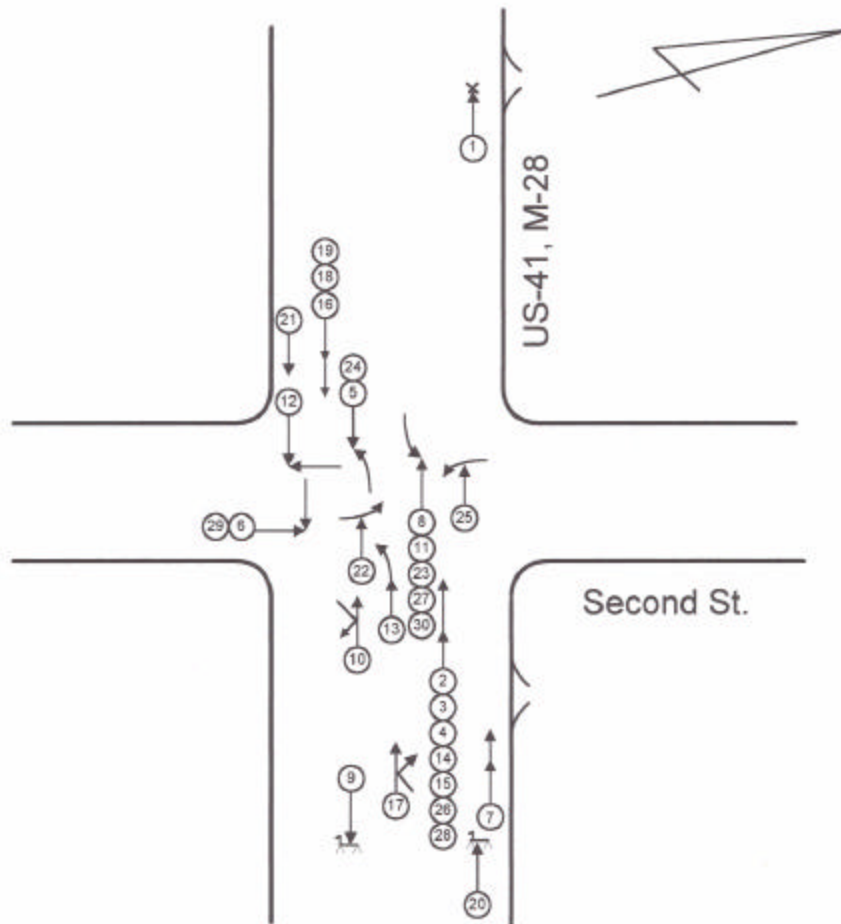
Diagram Number	Date	Time	Severity	Type	# of vehicles	Direction of travel	Pavement condition
1*	1/17/00	9-10P	PD	Misc	1	WBd	Snowy
2	1/22/00	1758	PD	RE	2	EBd	Icy
3*	2/13/00	5-6P	PD	RE	2	WBd	Icy
4*	2/26/00	3-4P	1-C	RE	2	WBd	Wet
5*	7/01/00	4-5P	PD	Hd on LT	2	W-EBd	Dry
6*	7/22/00	4-5P	1-C	Angle	2	N-EBd	Dry
7*	9/24/00	N-1P	1-C	Drive RE	2	WBd	Dry
8*	10/06/00	11A-N	1-A, 1-B	Hd on LT	2	E-WBd	Dry
9*	10/27/00	11P-M	PD	Deer	1	Ebd	Dry
10*	11/19/00	5-6P	PD	SSOP	2	W-Ebd	Icy
11*	12/08/00	4-5P	2-C	Hd on LT	2	W-Ebd	Slushy
12	1/07/01	0110	1-C	Angle	2	E-SBd	Snowy
13	1/14/01	1755	PD	RELT	2	Ebd	Snowy
14	2/09/01	1039	1-C	RE	2	WBd	Snowy
15	2/22/01	0853	PD	RE	2	WBd	Icy
16	3/05/01	0915	1-C	RE	2	Ebd	Snowy
17	3/19/01	1710	PD	RELT	2	WBd	Dry
18	4/04/01	1135	PD	RE	2	WBd	Dry
19	5/11/01	0745	PD	RE	2	Ebd	Dry
20*	5/23/01	2-3A	PD	Deer	1	WBd	Dry
21	7/23/01	0630	1-A	Misc	1	Ebd	Unknown
22	8/21/01	1935	1-C	Angle	2	N-WBd	Dry
23	8/25/01	1500	PD	Hd on LT	2	E-WBd	Wet

24	9/14/01	2040	PD	Hd on LT	2	E-WBd	Dry
25	3/28/02	0600	PD	Angle	2	S-WBd	Dry
26	7/07/02	1910	PD	RE	2	WBd	Wet
27	9/09/02	1619	2-B's	Hd on LT	2	E-WBd	Dry
28	10/20/02	1315	PD	RE	2	WBd	Wet
29*	12/17/02	8-9A	PD	Angle	2	N-Ebd	Dry
30	12/20/02	1441	PD	Hd on LT	2	E-WBd	Wet

30 Total - 19 Property Damage, 11 injury- 14 injured
12 Rear ends, 7 Head on Left Turns, & 5 angles

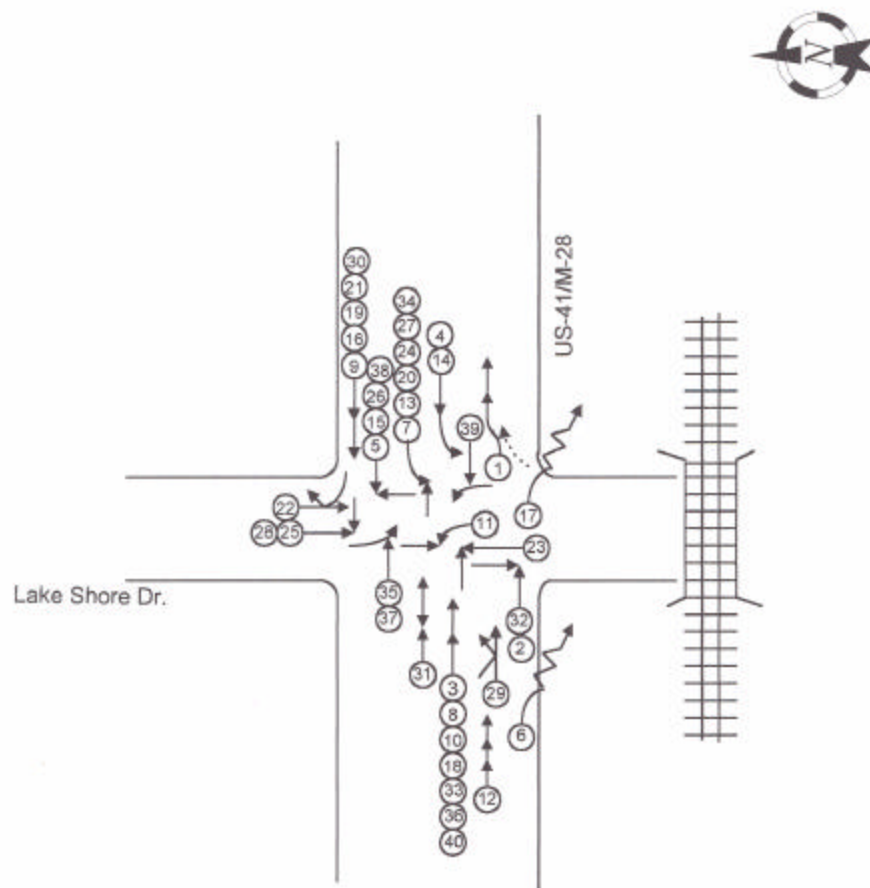
Diagram Number	Date	Time	Severity	Type	# of vehicles	Direction of travel	Remarks
1	2/04/00	1900	PD	SS+RE	3	E	Wet Pavement
2	2/07/00	1540	PD	Angle	2	S-E	
3	2/13/00	1035	PD	RE	2	E	Snowy
4	2/16/00	1920	PD	RELT	2	W	Wet Pavement
5	3/04/00	0823	1-B, 1-C	Angle	2	N-W	
6	3/15/00	2015	PD	ROR	1	E	Wet Pavement
7	4/30/00	1720	1-C	Hd on LT	2	E-W	
8	8/26/00	0625	1-B, 1-C	RE	2	E	Wet Pavement
9	9/02/00	1710	PD	RE	2	W	
10	10/12/00	1803	3-C	RE	2	E	
11	10/19/00	1544	PD	Hd on LT	2	N-S	
12	11/07/00	1841	PD	RE	3	E	
13	11/10/00	2145	PD	Hd on LT	2	E-W	
14	3/05/01	1700	PD	RE LT	2	W	Snowy
15	3/30/01	1604	2-B, 1-C	Angle	2	N-W	
16	4/04/01	1558	2-B, 1-C	RE	2	WBd	
17	6/01/01	1805	PD	R O R	1	E	
18	6/10/01	1555	1-C	RE	2	E	Wet pavement
19	8/24/01	1640	PD	RE	2	W	
20	9/28/01	1538	PD	Hd on LT	2	E-W	
21	10/29/01	1202	4-C	RE	3	W	
22	11/26/01	2000	PD	RT	2	W-S	Snowy
23	12/23/01	1225	PD	Angle	2	N-E	Icy
24	2/23/02	1935	PD	Hd on LT	2	W-E	Wet pavement
25	3/16/02	1655	1-B, 1-C	Angle	3	S-W

26	4/12/02	2355	2-A, 3-C	Angle	2	N-W	
27	4/24/02	1652	2-C	Hd on LT	2	E-W	wet pavement
28	5/03/02	1819	PD	Angle	2	S-W	
29	5/21/02	0750	PD	SS SM	2	E	
30	7/12/02	1610	PD	RE	2	W	
31	7/28/02	1550	PD	Backing	2	E	
32	9/29/02	1307	1-C	Angle	2	S-E	
33	11/12/02	1140	1-C	RE	2	E	
34	12/01/02	2056	PD	Hd on LT	2	E-W	Snowy
35	12/02/02	1836	1-C	Angle LT	2	S-E	93 yr old driver
36	12/05/01	2-3P	1-C	RE	2	E	
37	10/25/01	11-N	1-F, 1-C	LT Angle	2	S-E	
38	5/12/01	6-7A	1-C	Angle	2	N-W	
39	2/17/01	2-3P	1-B	LT Angle	2	N-W	
40	1/26/01	8-9P	PD	Drive RE	2	E	Snowy

40 Total Collisions -
 22 Property Damage, 18 injury - 35 injured 1 Fatal
 12 Right Angles, 16 Rear Ends, 7 Head on Left Turns
